Department of Energy

Oak Ridge Operations
Weldon Spring Site
Remedial Action Project Office
Route 2, Highway 94 South
St. Charles, Missouri 63303

DISMANTLING OF BUILDING 409

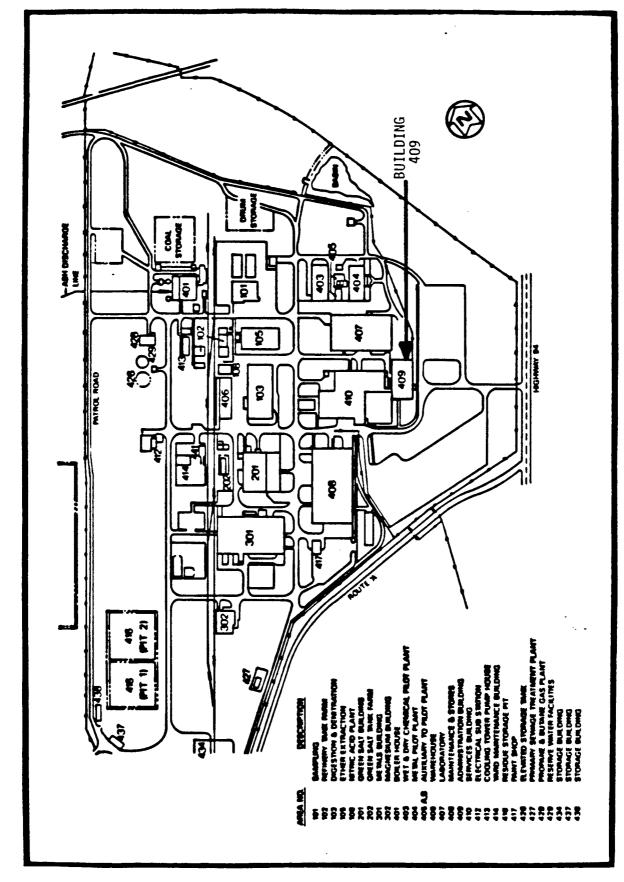
FIGURE 1 Location of Major Structures at the Weldon Spring Site (Source: Bechtel National 1986)

Building 409 was used as an administrative office building during the operational period of the chemical plant. It is located in the eastern portion of the Weldon Spring complex (Fig. 1) about 90 m (300 ft) southwest of the plant, from which it is separated by a former laboratory building. Since the termination of site activities, Building 409 has remained unoccupied.
